INSPECTION CONDITIONS

Report Name: Clopton.

Inspection Date: 9-22-11.

Inspection Site: #10 Walking Woods.

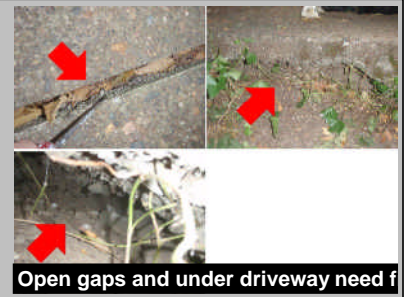
Driveway Condition:	<p>Attention Needed - The driveway needs attention and minor repair to prevent further deterioration.</p>
----------------------------	---

Comments:	<p>Overall the condition of the concrete flatwork is in satisfactory condition. It is recommended that the areas where wooden expansion joints were located by the front entry and now are missing be sealed to prevent any further water intrusion that may run under the driveway. Also under the east side of the driveway there is a area that has eroded and needs to be filled to prevent any breakage of the concrete driveway.</p>
------------------	--

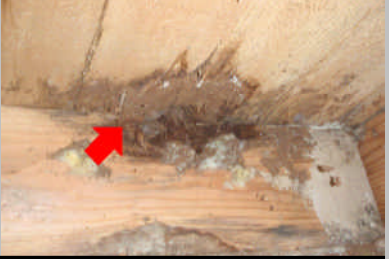
There were several condition noted in the crawlspace area.
There are areas of missing vapor barrier and some of the exposed dirt area have some organic material growing (no mold test was completed)
Recommend that the crawlspace be covered with 6 mill black visqueen.
On the lower NE corner of the crawlspace there is evidence of water collection, there is a low point drain however this drain was plugged with dirt.
Recommend that this low point drain be cleared to allow water to exit the crawlspace.

Decay under living room sliding door.

There are several sections of wall that lead to a living area where insulation has been removed or missing.
Recommend that these walls be re-insulated.
The section below the sliding glass door in the living room on the right side shows evidence of past water leakage,
Recommend that a licensed contractor further evaluate and repair any leak or decayed areas.

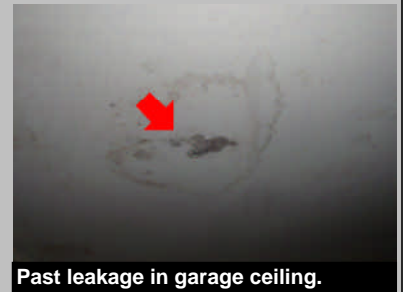
Past leakage noted in garage area .

Past leakage in garage ceiling.

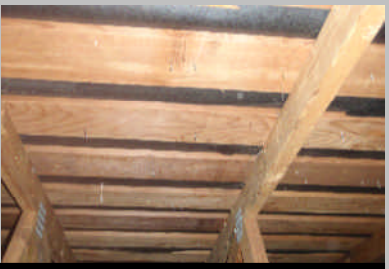
Open slates for roof decking in truss area

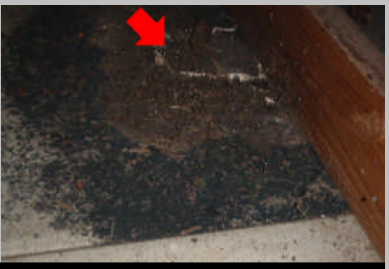
Evidence of Leaks on Interior of Attic: There is water staining on the underside of the roof decking or rafters. The stains are not currently wet nor do they have an elevated moisture content.

Past leak in garage ceiling area.

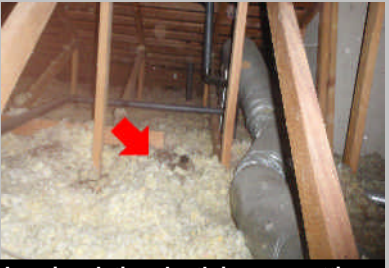
Low insulation depth in upper attic

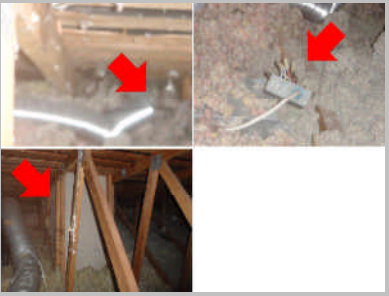
There is no insulation around the walls of the skylight this area should be insulated to prevent heat loss.

The master bathroom fan is directed to a soffit vent this vent should be attached to the vent or run to a upper roof vent to prevent moisture from entering the attic area.

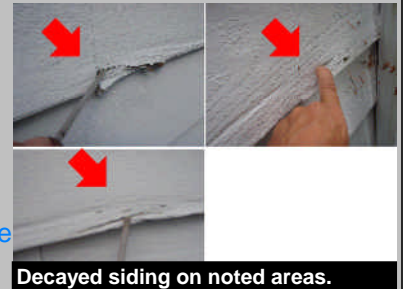
Overall the siding is in satisfactory condition, However there are areas that some of the siding has decayed.

On the wall above there are several siding boards that are decayed and need to be replaced.

The area off the master bedroom deck has several pieces of siding that are decayed on the west side of the siding door.

Some of the siding where the main deck adjoins the house have become decayed because the ledger is directly placed on the siding where water can collect and decay the siding.

Decayed siding on noted areas.

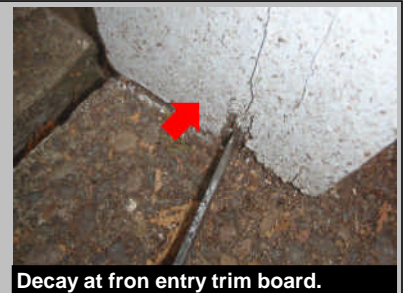
Decay at front entry trim board.

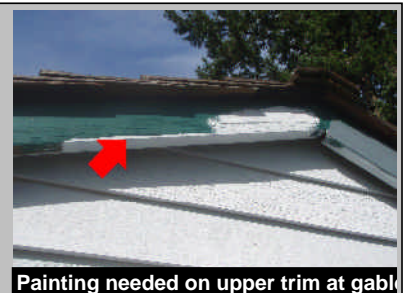
Attention Needed - The fascia and/or rake boards appear to need some minor repair to prevent further deterioration.

Painting needed on upper trim at gable.

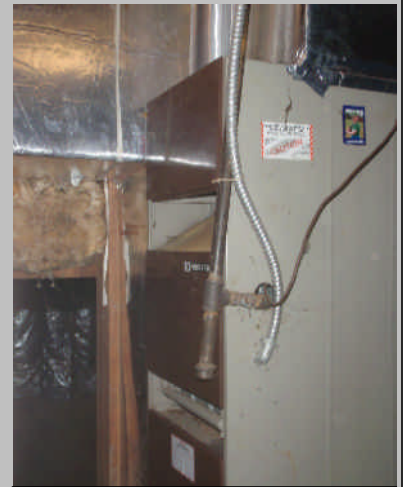
Furnace in crawlspace area.

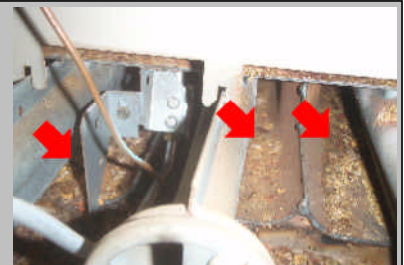
Rust debris at burners.

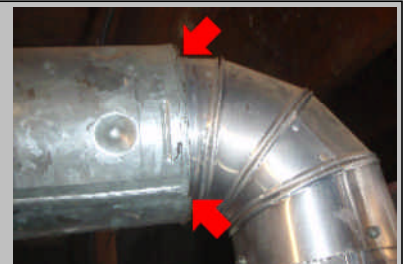
Attention Needed - The furnace/boiler flue as installed appears to need some attention. Either it is not secured properly, or it is in a deteriorated condition.

Connection not properly secured.

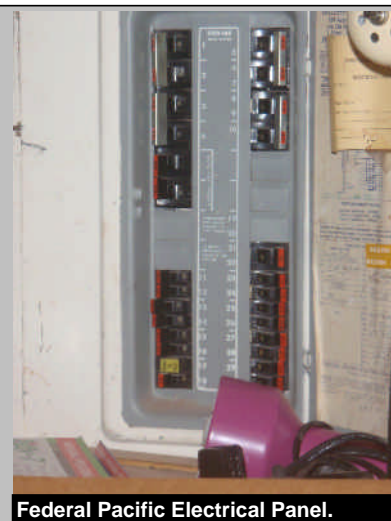
Federal Pacific Electrical Panel.

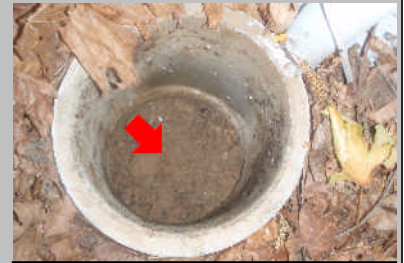
Shut-off covered with dirt.

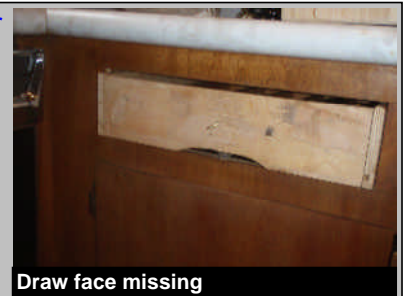
Attention Needed - At least one cabinet door or drawer is in need of some minor repair.

Draw face missing

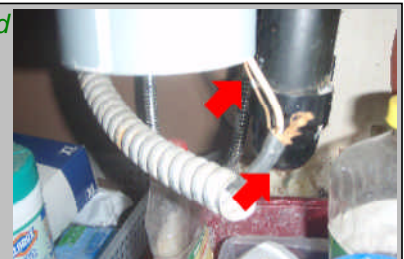
Action Necessary - The food waste disposal did not activate using normal controls. Further investigation is needed to determine if repairs or replacement should be done.

Wire connection missing at base.

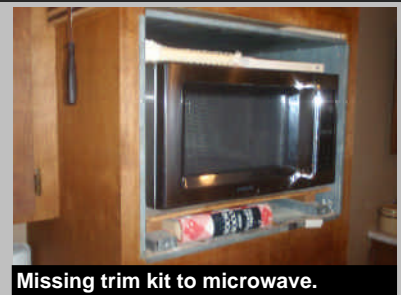
Action Necessary - There is a microwave unit installed however a trim kit is missing .

Missing trim kit to microwave.

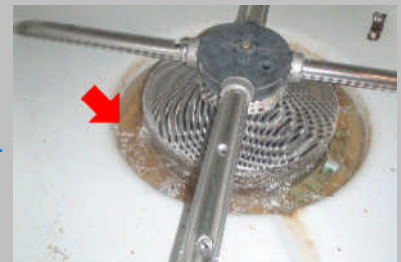
Standing water in Dishwasher.

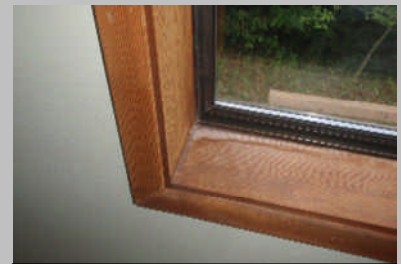
Attention Needed - At least one window or associated hardware in this bedroom needs attention. Locking hardware needs repair or replacement.

Stains on corners of window sill.

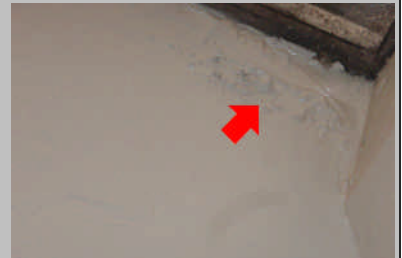
Past leakage at corner of skylight.

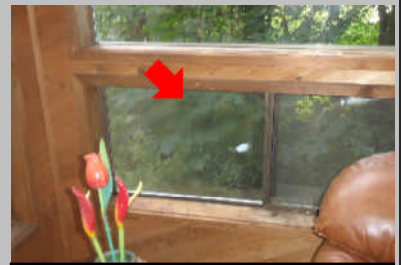
Attention Needed - Window on the east side seal is broken.

Seal broken on lower window.

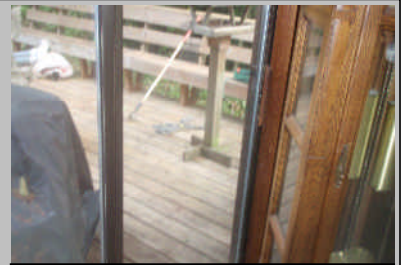
Could not open siding glass door.

One of the windows on the east side has a broken seal.
This inspector could not open the sliding glass door on the NW side, this is also the door that has possible leak on the right side that was noted by decay in the lower crawlspace.
Water stains were noted on windows sills (possibly from metal windows the has condensation on winter days.)
