INSPECTION CONDITIONS

Report Name: Clopton.

Inspection Date: 9-22-11.

Inspection Site: #10 Walking Woods.

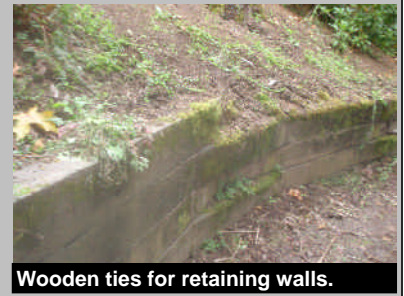
Upper west side and on east side of driveway.

The retaining wall is made of stacked railroad ties.

Satisfactory - The retaining wall is in functional condition.

The wood tie retaining walls that are located on the west and east side of the house are in satisfactory condition. With this type of wall water can drain from behind the walls. No bowing or sagging was noted.

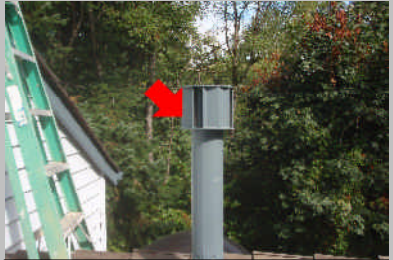
There is at least one gas-fired vent stack
through the roofline.

Venting is satisfactory.

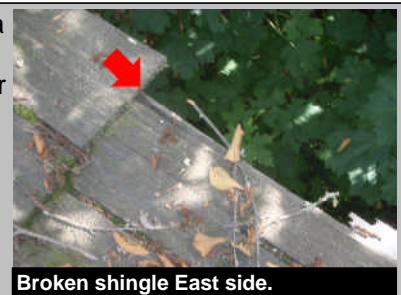
Satisfactory - The roof covering material is in a condition that is consistent with its age and method of installation, showing no deficiency or cause for immediate concern.

The roof covering material appears to have a remaining life expectancy of 5 to 8 years, assuming proper maintenance is completed as needed.

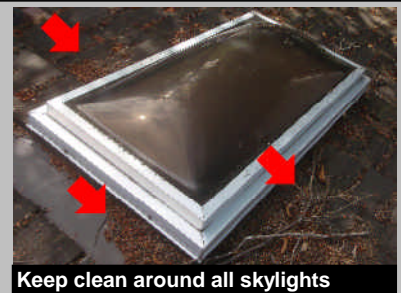
Satisfactory - The skylight(s) appears to be satisfactory and shows no signs of leaking.

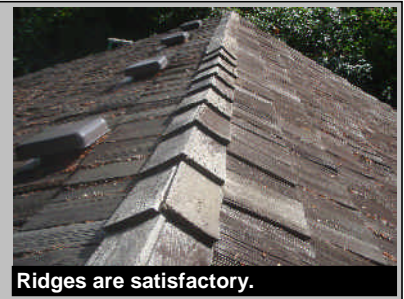
Satisfactory - The ridge covering material appears to be in satisfactory condition.

Ridges are satisfactory.

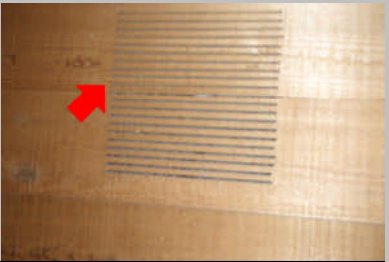
<p style="text-align: right;">Heat circulation system on upper FP</p>
Hearth Condition:	The hearth extends at least 16" in front of the firebox and extends at least 8" to either side.

Comment:	<p>There are two metal wood burning fireplaces installed. The upper fireplace is located in the loft area. This is a metal box type of wood burning fireplace. The flue was clean and the damper in good working condition. This fireplace also has a heat circulator installed.</p> <p>The lower fireplace is located in the family room next to the kitchen. This is also a metal box type of fireplace. The damper and firebox are satisfactory. It is recommended that this fireplace flue be cleaned and serviced.</p>

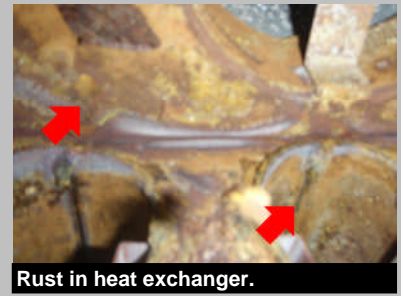
Yes. The general conditions prohibit a visual inspection of a large percentage of the heat exchanger. This is primarily due to the style and shape of the heat exchanger, but the visible portions were inspected.

The heat exchanger was tested by a visual inspection with the aid of a flashlight and mirrors, and no cracks or voids were noted.

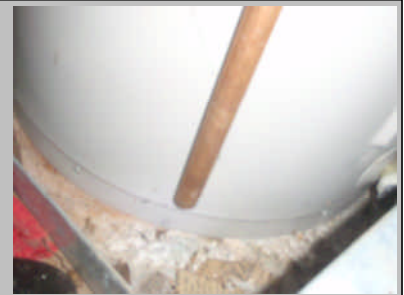
Satisfactory - The overflow pipe is correctly installed.

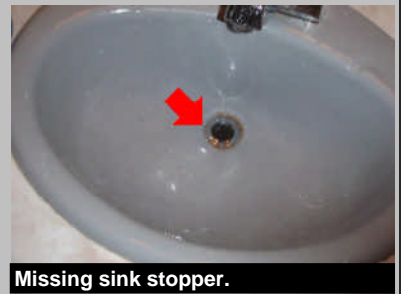
Attention Needed - The basin or drainage fixture needs attention. The basin stopper is missing.

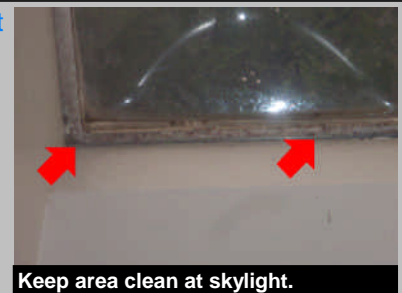
The tub shower valve does not completely shut water off to the tub when the shower is on , minor adjustments are needed.
The skylight above the tub is prone to catching steam from the shower area recommend that this area be kept clean to prevent any decay. Also as noted earlier in this report the sides of the skylight should be insulated to prevent any heat loss.
The GFCI protect electrical outlet is controlled in the garage electrical panel.

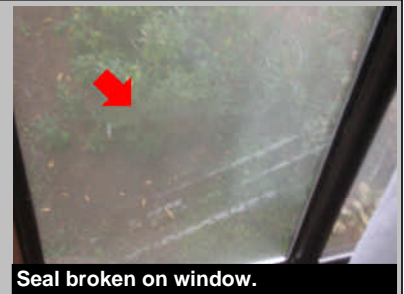
Attention Needed - At least one window or associated hardware in this bedroom needs attention.

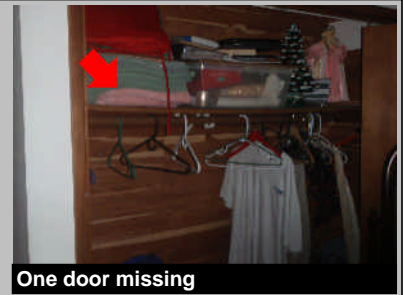
Attention Needed - The closet doors or fixtures need some adjustment or repair.

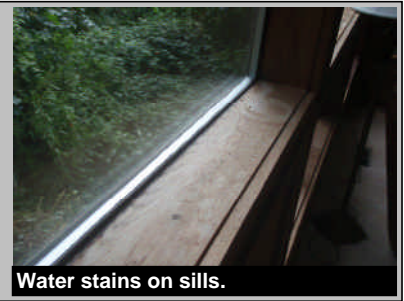
One of the windows on the east side has a broken seal.
This inspector could not open the sliding glass door on the NW side, this is also the door that has possible leak on the right side that was noted by decay in the lower crawlspace.
Water stains were noted on windows sills (possibly from metal windows the has condensation on winter days.)

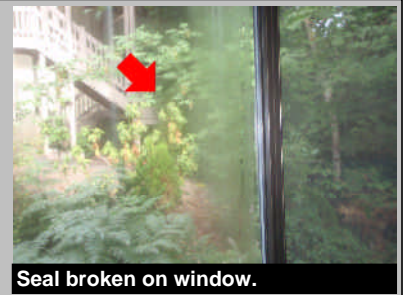
Attention Needed - Seal broken on window.

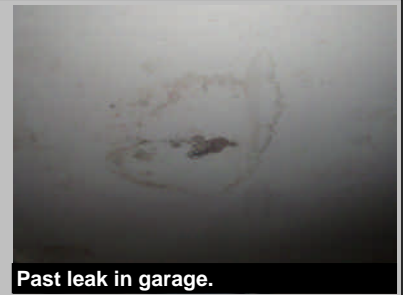
Yes - There appears to be a fire rated separation between the garage ceiling and the living areas above. **Attention Needed - Previous Leak** - There are signs of a previous water leak in the ceiling in this room. It does not appear to be an active leak.

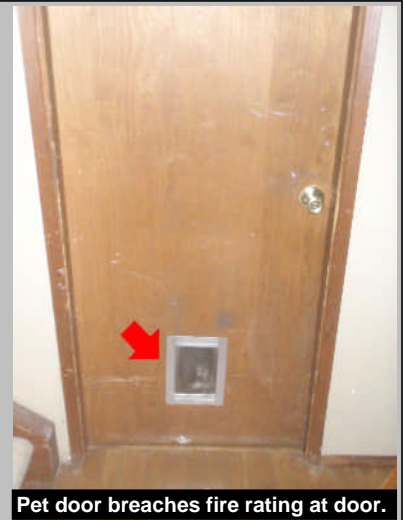
Recommend - For safety reasons, there should be a fire rated door or a solid core door, as a minimum, between the garage and living areas of the house.
